Basik air concept 2010 RN 97 83340 Le Luc FRANCE Document I-2	BULETTIN DE SERVICE - SERVICE BULLETIN NIVEAU: OBLIGATOIRE - MANDATORY	N° /AN Date: 03 /11 /05 Page 1/6
	TEL: 04 94 99 12 36	FAX:04 94 39 89 37

Sac-harnais/ Harness-container Advance

Subject: Addendum of S.B. n° 051101 from 3/11/05

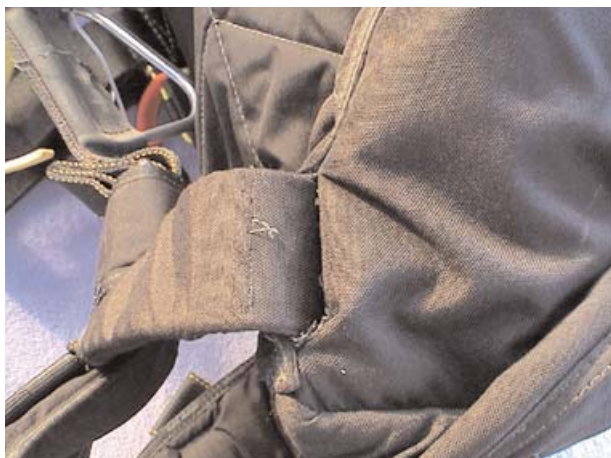
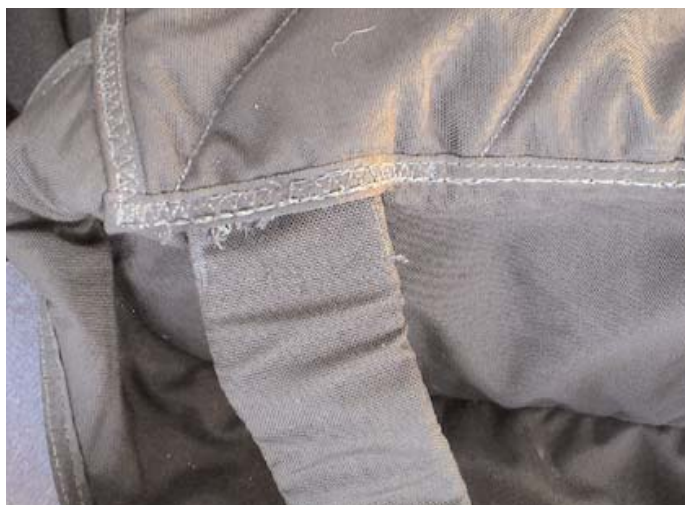
Container junction with the lateral webbing as been slightly damaged too.

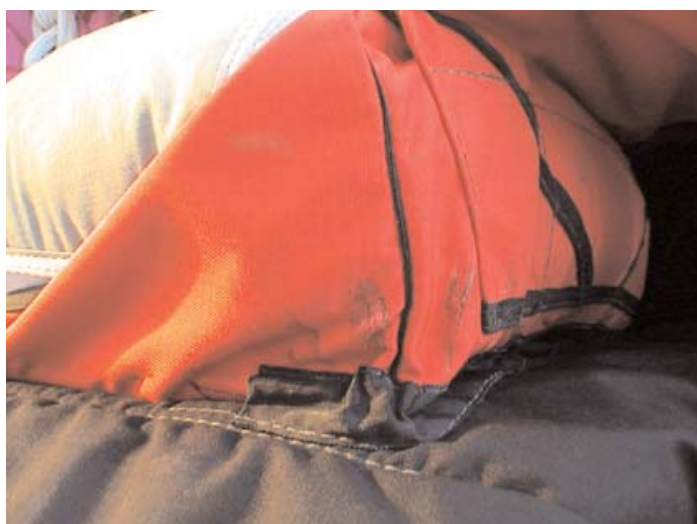
Several burns done by the main canopy lines and risers are on the reserve container divider flap and on the reserve bag as well.

Stiches from the reserve container reinforcement tape are damaged too.
